MARINA AND PARK DEVELOPMENT STUDY

VILLAGE OF ELK RAPIDS ANTRIM COUNTY, MICHIGAN

AUGUST, 1980

PREIN & NEWHOF, P.C. ENGINEERS-PLANNERS 3000 East Beltline, N.E. Grand Rapids, Michigan 49505 Project No. 79058

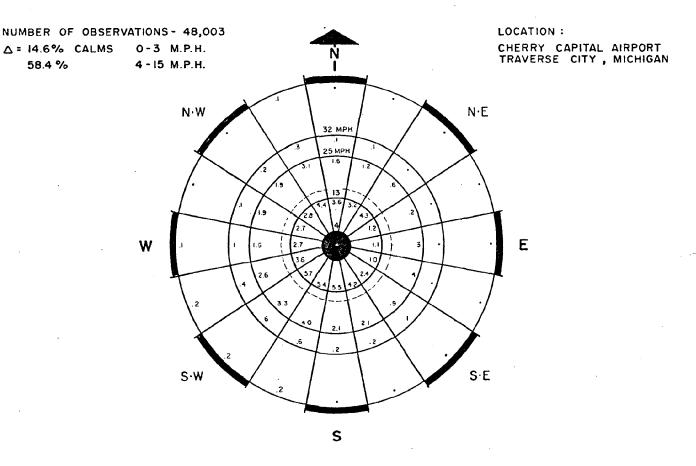
WIND ROSE

In order to determine the requirements of any proposed shoreline protection or upgrading of the breakwaters, a wave analysis, based on U.S. Army Coastal Engineering Center methods was performed. Effective fetch distances were calculated and related to wind records as recorded at the Traverse City, Cherry Capitol Airport. This analysis indicates storms from the west-southwest direction may generate waves in the 3 to 4 foot height range and northerly storms may generate waves in the height range of 4 to 6 feet depending on duration times.

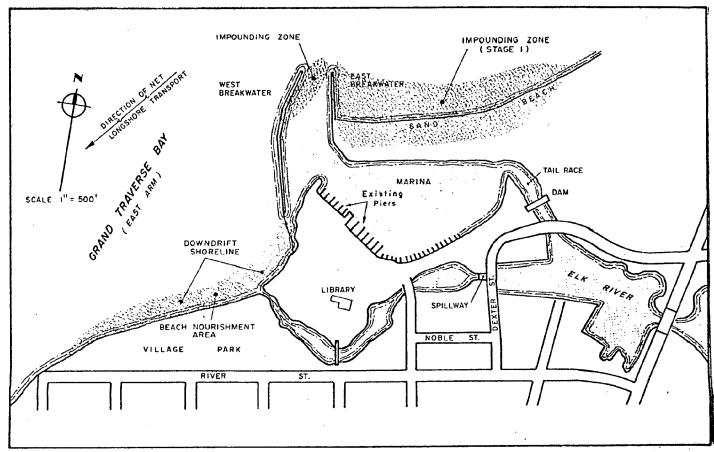
A beach nourishment program to rebuild the shoreline along the Park is recommended to replenish the beach and offset the effects of the Harbor breakwaters. The east and west breakwaters constitute a barrier to the natural longshore littoral transport and create impounding zones along the east breakwater and the channel entrance. The acretion along the east breakwater (stage 1 impounding zone) is clearly evident by comparison of 1964 aerial photographs with present conditions. In 1964 there was no sand beach along the east breakwater. Since that time littoral deposition has formed a sand beach approximately 250 feet wide with a corresponding depletion of the downdrift shoreline along the park. Periodic by-passing of sand from the breakwater area to the beach area would accomplish the artificial nourishment of the beach as well as reducing the effect of the impounding zone at the channel entrance. Based upon past conditions, renourishing the beach in this maner should be done every 5 to 7 years depending on the level of Lake Michigan and the severity of winter storms which are predominately from the northwest.

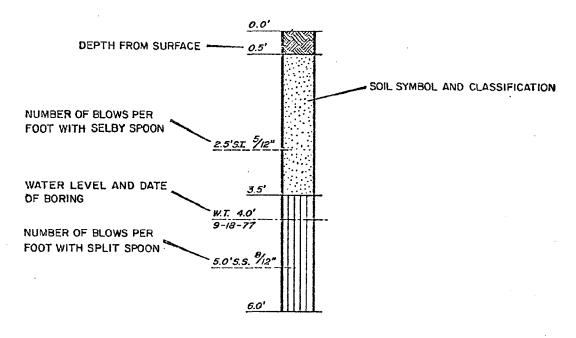
LEGEND - SOIL BORING LOG

PENETRATION TESTS ARE MADE WITH A 2" DIAMETER SPLIT SPOON, 140 POUND HAMMER WITH 30" FREEFALL UNLESS OTHERLESS NOTED.

S.S/12" DENOTES TYPE OF SAMPLER AND NUMBER OF BLOWS TO DRIVE SAMPLER 12"

CLASSIFICATIONS ARE MADE BY VISUAL INSPECTION. THE WATER LEVELS AS INDICATED ARE THOSE OBSERVED WHEN THE BORING WAS MADE OR AS NOTED.

SYMBOLS COMBINED WHEN NECESSARY TO SHOW VARIATIONS.
